***Arroyo Hondo
Culvert Modification/
Steelhead Passage
Conceptual Design Report***

***Ms. Carolyn Chandler
Land Trust for Santa Barbara County
1114 State Street, Suite 204
Santa Barbara, CA 93101***

***Questa Engineering Corporation
1220 Brickyard Cove Road, Suite 206
P. O. Box 70356
Point Richmond, California 94807
(510) 236-6114***

August 3, 2004

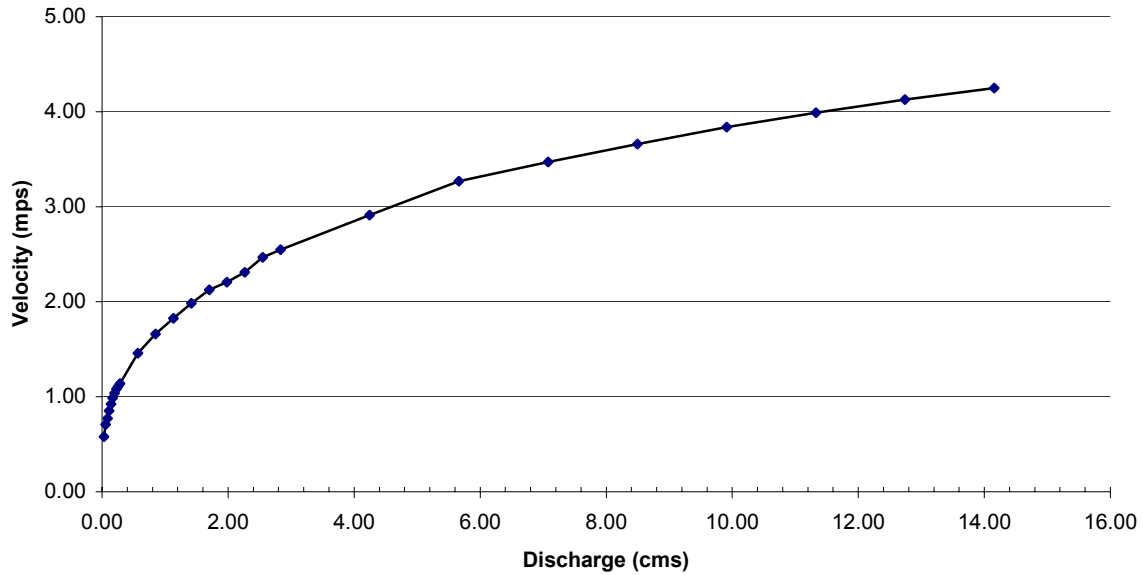
Figure 10. Average Culvert Velocity (mps)

Note: data is for cross section 1+57

Figures 10 through **13** show velocity-discharge and depth-discharge curves for the culvert. Fish passage criteria are discussed further in **Section 4 - Proposed Project**, but hydraulic model results show that due to fish passage velocity and depth constraints, the culvert under existing conditions is passable during flows ranging from 0.14 cms to 1.13 cms (5 to 40 cfs).

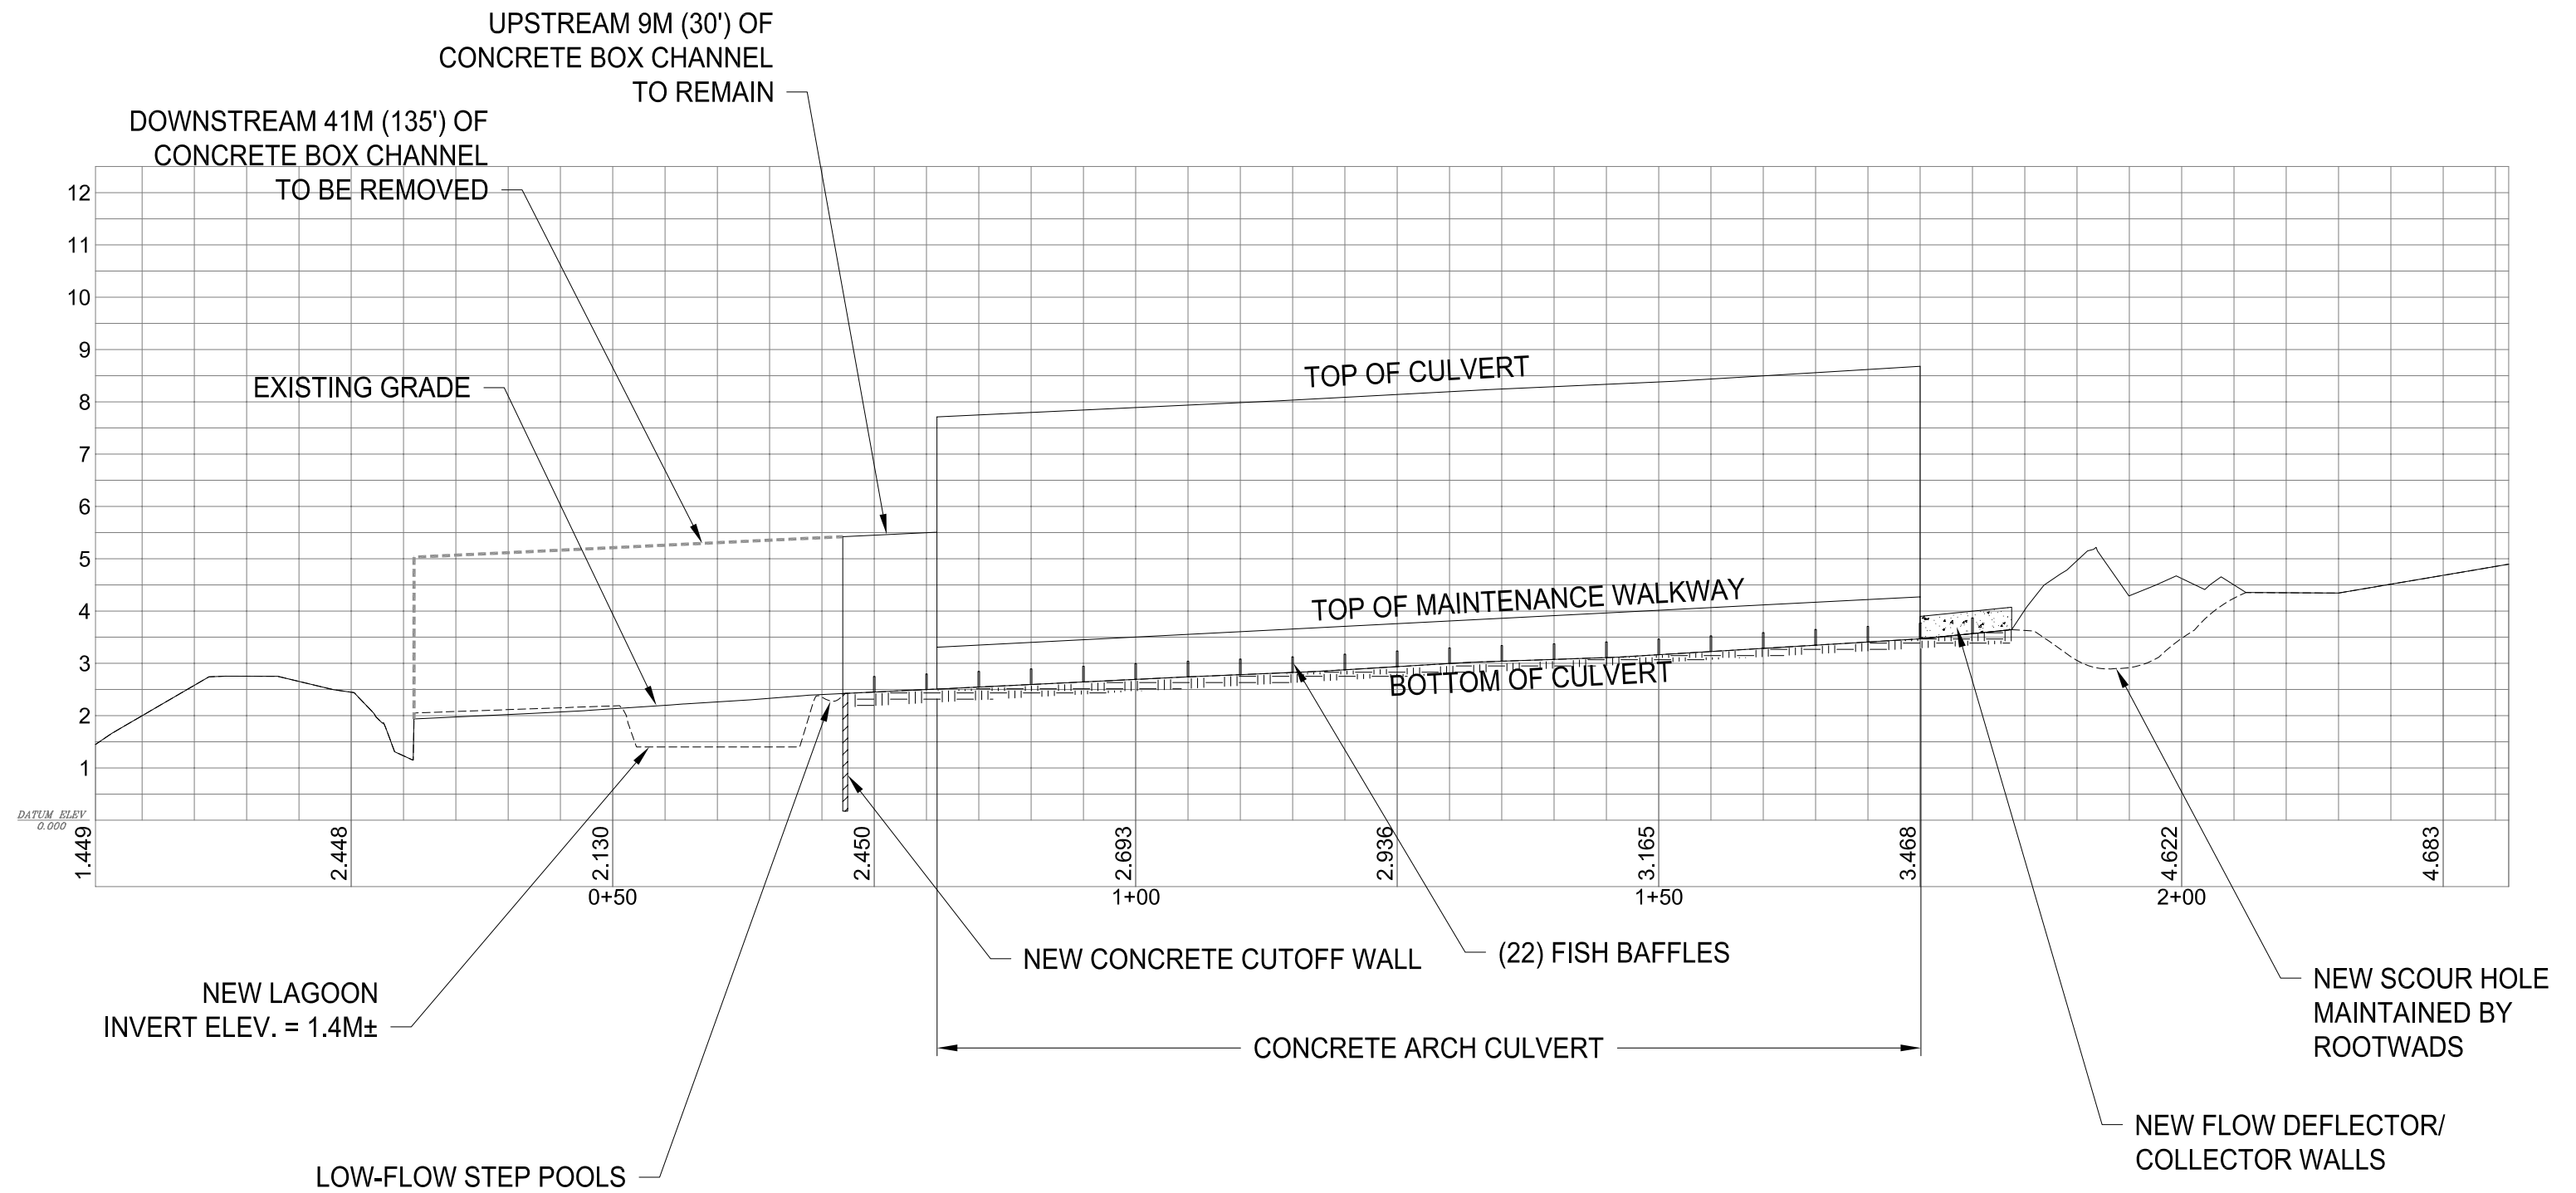
FIGURE
3

PROFILE

**PROFILE OF DRAFT SITE PLAN
ARROYO HONDO STEELHEAD PASSAGE**
LAND TRUST FOR SANTA BARBARA COUNTY,
CALIFORNIA

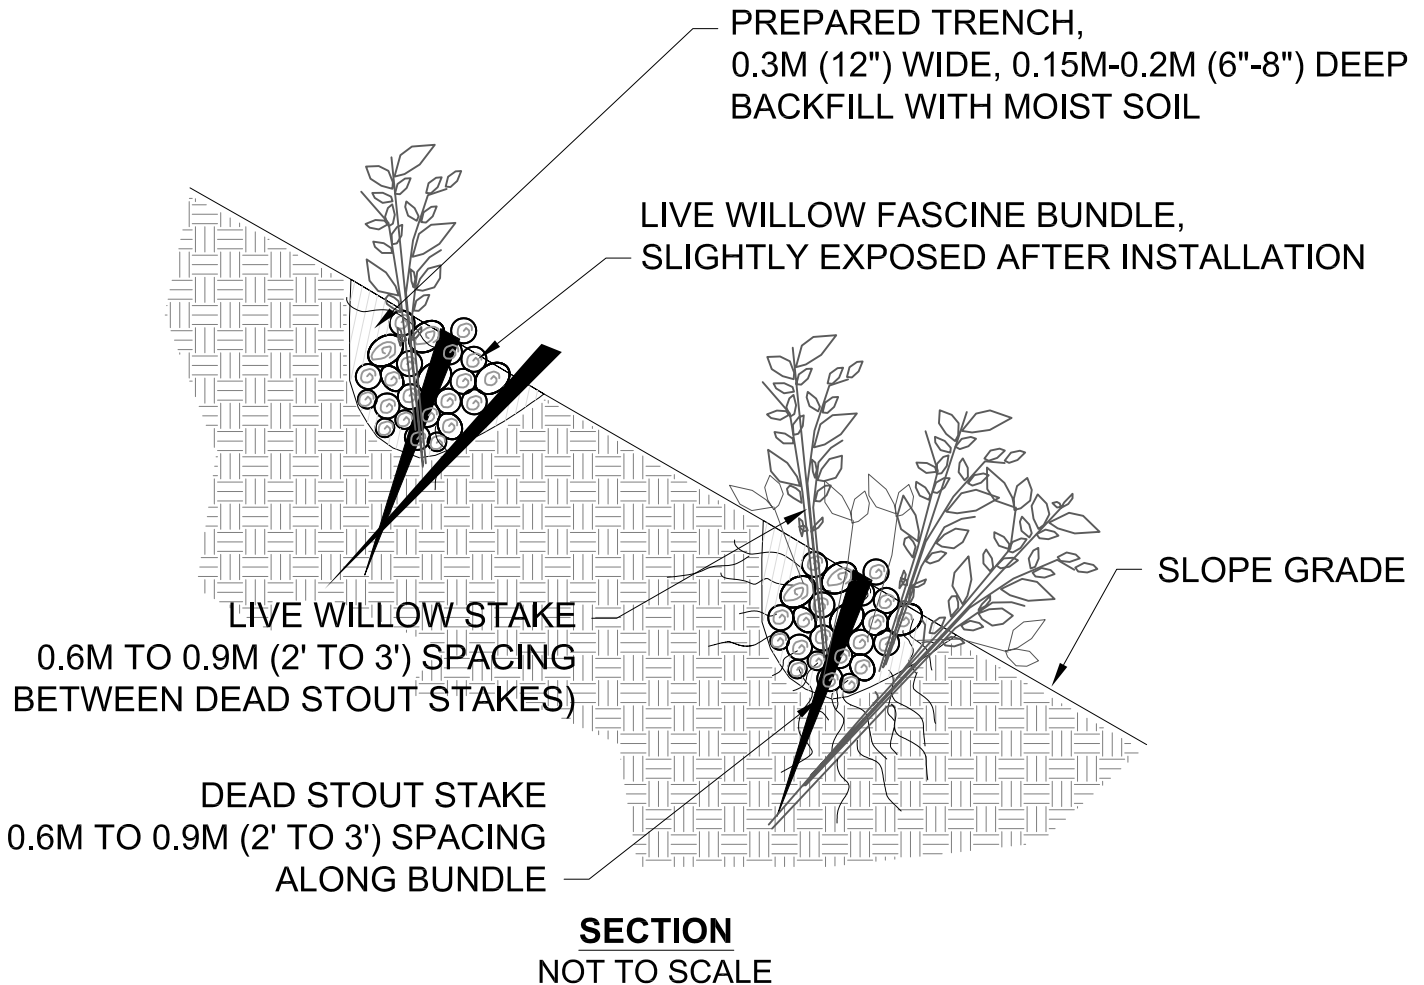
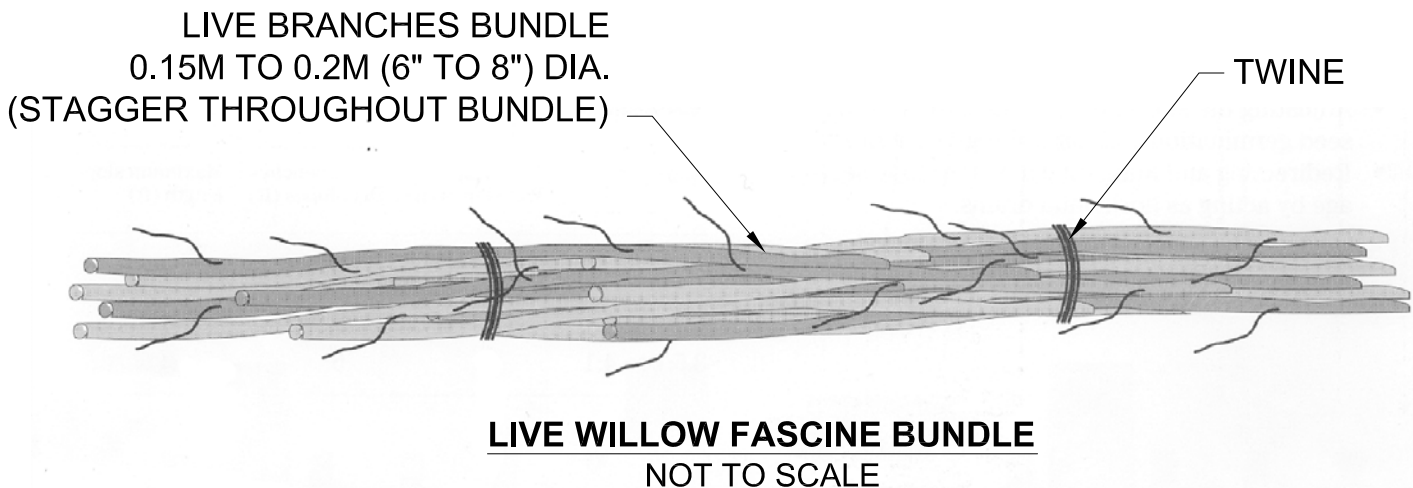
**FIGURE
 5**

**WILLOW WATTLING SLOPE PROTECTION
 ARROYO HONDO STEELHEAD PASSAGE
 LAND TRUST FOR
 SANTA BARBARA COUNTY, CALIFORNIA**

- **Biotechnical slope protection.** The newly graded slopes of the lagoon will be treated with a biotechnical bank stabilization technique. Willow stakes and/or fascines will be used to ring the lagoon (**Figure 5**). Other species will be planted in more upland areas to establish an appropriate coastal riparian vegetation association. Biodegradable erosion control fabric will be used to help stabilize the sandy soils prior to the establishment of the vegetation. The goal of this revegetation is to create a lagoon fringed by willows that provide cover for fish and for red-legged frogs.

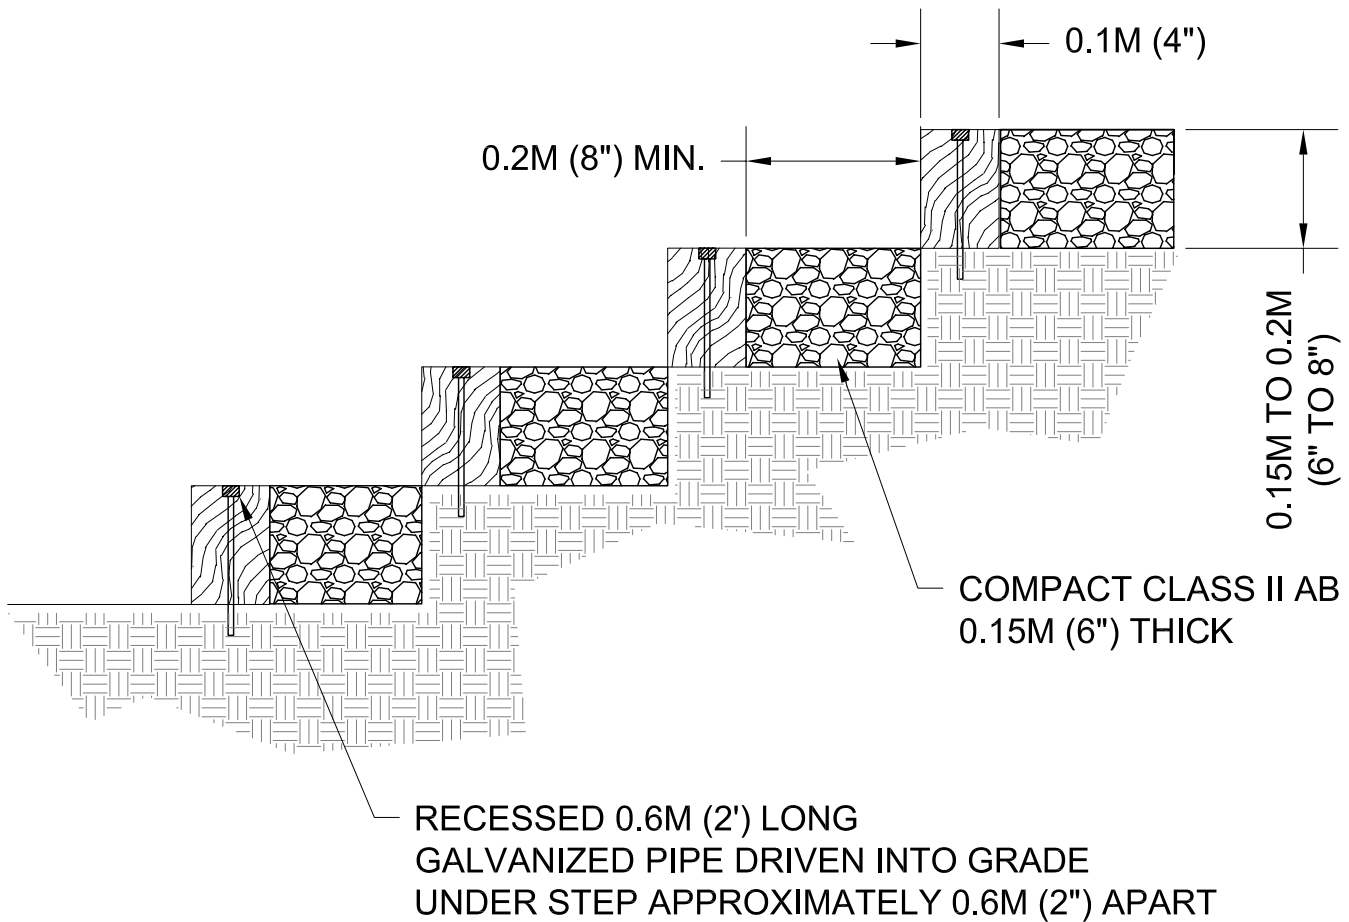
FIGURE
4

WOODEN STEPS DETAILS
ARROYO HONDO STEEL HEAD PASSAGE
 SANTA BARBARA COUNTY, CALIFORNIA

- **Beachside trail.** Along with the lagoon reestablishment, a new trail segment will be created that extends from the culvert mouth to the beach. This trail will be routed along the north side of the lagoon and under the rock outcropping that protrudes along the north side of the arroyo mouth. Steps will be created as the trail exits the culvert (**Figure 4**). A new trail foundation (station 0+25), based on

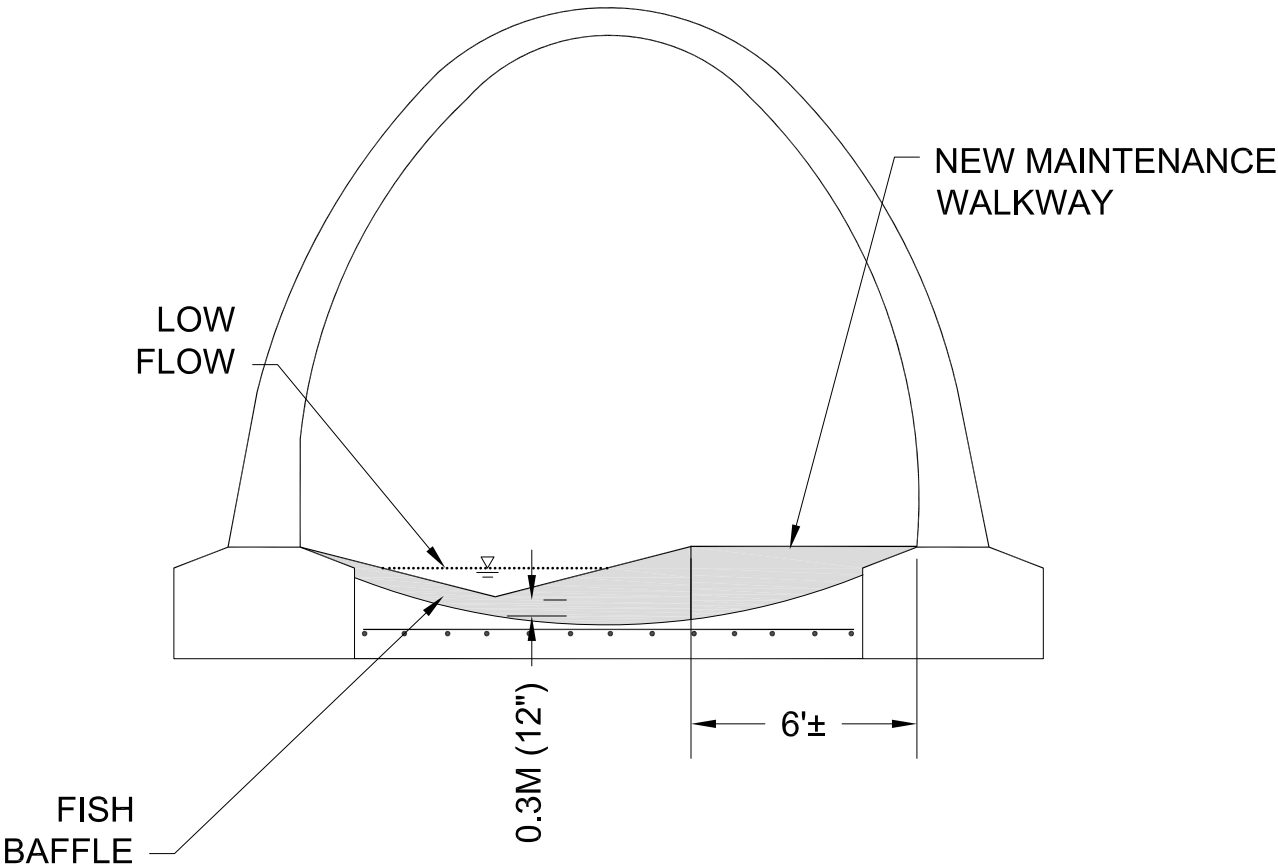
**CROSS-SECTION □
LOOKING DOWNSTREAM**

Date: 06 / 07 / 04	<div> <p>QUESTA ENGINEERING CORP.</p><p><small>(510) 236-6114 FAX (510) 236-2423 questa@questaec.com</small></p><p><small>P.O. Box 70356 1220 Brickyard Cove Road Point Richmond, CA 94807</small></p></div> <div><p><i>Civil Environmental & Water Resources</i></p></div>	<p>FISH BAFFLE CROSS-SECTION ARROYO HONDO STEELHEAD PASSAGE LAND TRUST FOR SANTA BARBARA COUNTY, CALIFORNIA</p>	<p>FIGURE 6</p>
Drawn: T.H./C.H.H.			
Appr'd: S.T.			
Proj. No: 230092

Integral to increasing fish passage in Arroyo Hondo is retrofitting the culvert so that the window of upstream fish migration can be extended. This allows a greater opportunity for fish to move into the watershed and ensures greater spawning and rearing success. At present, flows move through the culvert at high velocities and low depths. There is a small window of flow regime where depth and velocities allow for successful fish passage. The existing conditions report documented the hydraulics of culvert and is summarized in **Section 7 - Hydraulic and Hydrologic Analysis**. Improving fish passage within the culvert means increasing depth and reducing velocities at the lower flow scenarios. The following components are proposed for the culvert structure. These features are shown on **Figures 2, 6, and 7**.

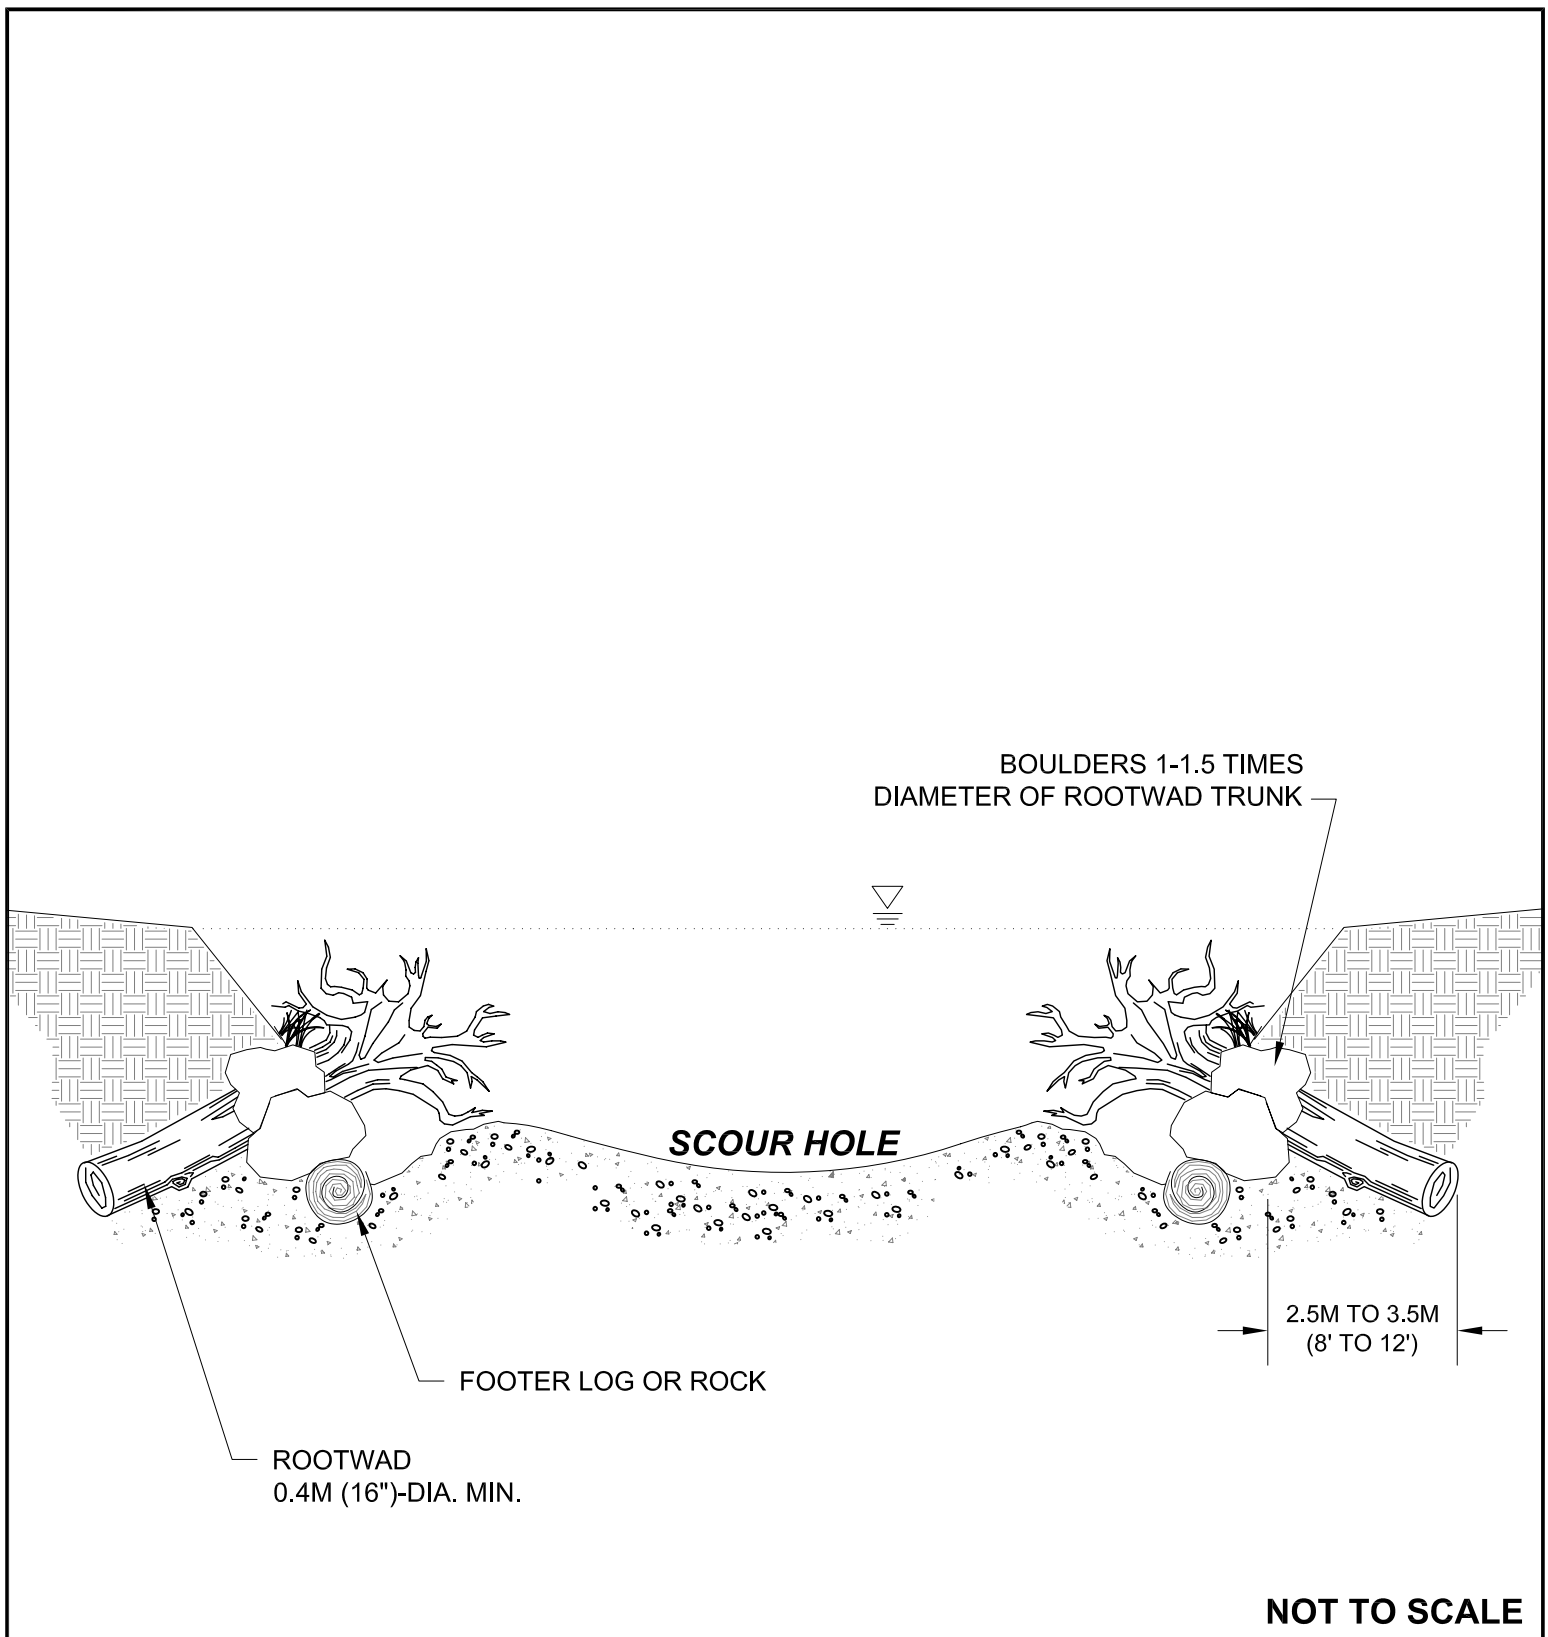
Date: 06 / 07 / 04	  <p>QUESTA ENGINEERING CORP.</p> <p><i>Civil Environmental & Water Resources</i></p> <p>(510) 236-6114 FAX (510) 236-2423 questa@questaec.com</p> <p>P.O. Box 70356 1220 Brickyard Cove Road Point Richmond, CA 94807</p>	<p>UPSTREAM RESTING POOL & ROOTWAD DETAILS</p> <p>ARROYO HONDO STEELHEAD PASSAGE</p> <p>LAND TRUST FOR SANTA BARBARA COUNTY, CALIFORNIA</p>	<p>FIGURE</p> <p>8</p>
Drawn: C.H.H.			
Appr'd: S.T.			
Proj. No: 230092

The Arroyo Hondo channel upstream of the culvert was straightened when the culvert was constructed. This straightening increased the gradient and likely destroyed numerous resting pools. The need for a resting pool upstream of the culvert was requested during the stakeholder meetings concerning project alternatives. The geomorphic studies indicated that sediment deposition has recently occurred in this area; creating a pool requires alteration of the hydraulic conditions so that turbulence and higher localized velocities prevent the accumulation of sediment.
